# **DuPont<sup>™</sup> Kalrez<sup>®</sup> 9100**

For PECVD and HDPCVD Processes

**Technical Information — June 2013**

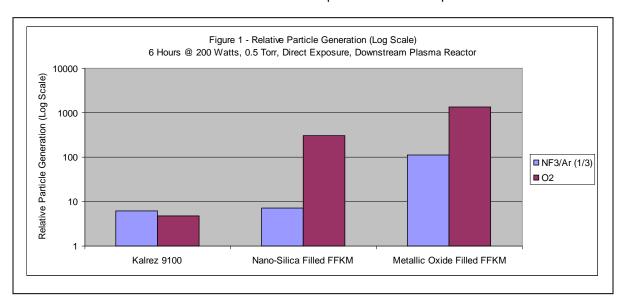
Conventional perfluoroelastomer (FFKM) sealing materials normally contain carbon black and/or mineral fillers. Newer products are either unfilled or formulated with polymeric fillers. Plasma resistance can be significantly different depending on the type of filler used. If the filler has high resistance to plasma, such as BaSO₄, TiO₂, etc., it can "shield" the polymer to reduce erosion or weight loss, but have the high potential for particle generation by leaving discrete particles behind once the polymer has become etched. Unfilled and polymeric filled products essentially contain no other elements other than carbon, fluorine and oxygen, which can be completely etched to form volatiles, thereby significantly reducing the potential for contamination. Figure 1 shows the relative particle generation of DuPont Kalrez® 9100 versus a nano-silica and a metallic oxide filled FFKM product in different plasmas.
